Collingham Monitoring Appraisal and Evaluation

CHLOE GLENCROSS
UNIVERSITY OF LEEDS

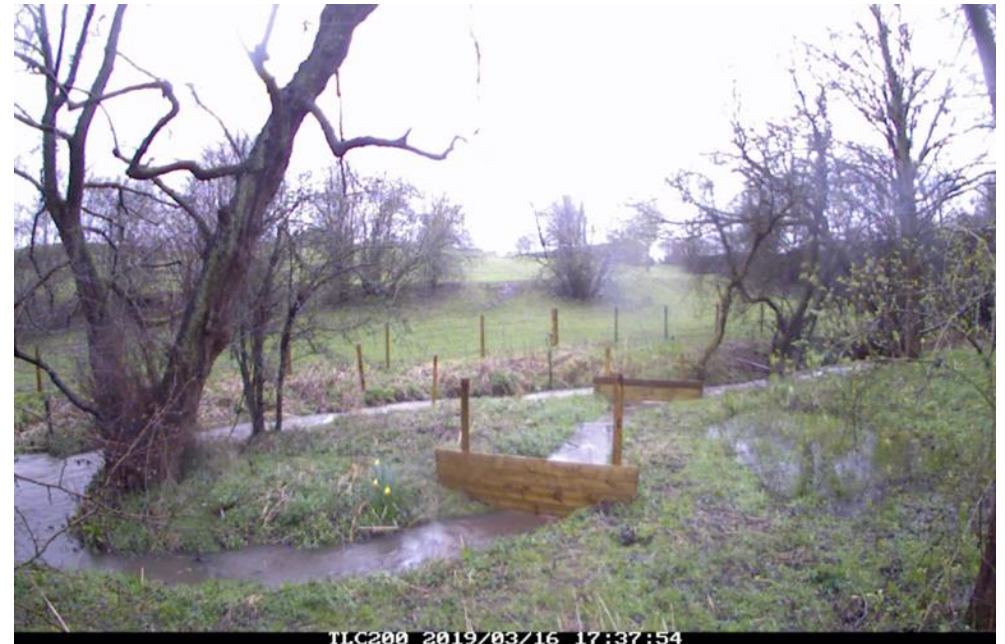
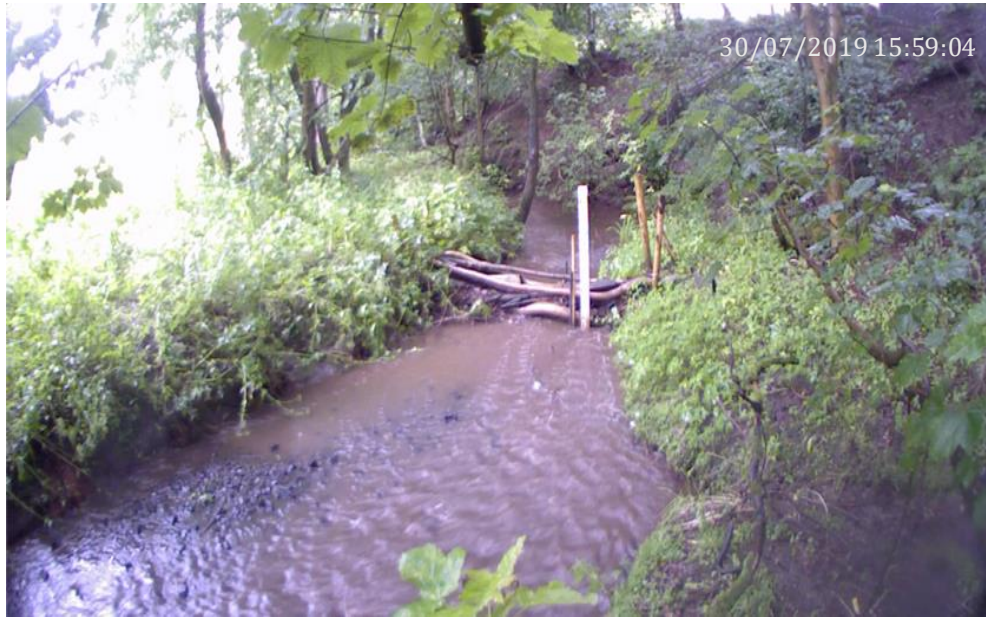
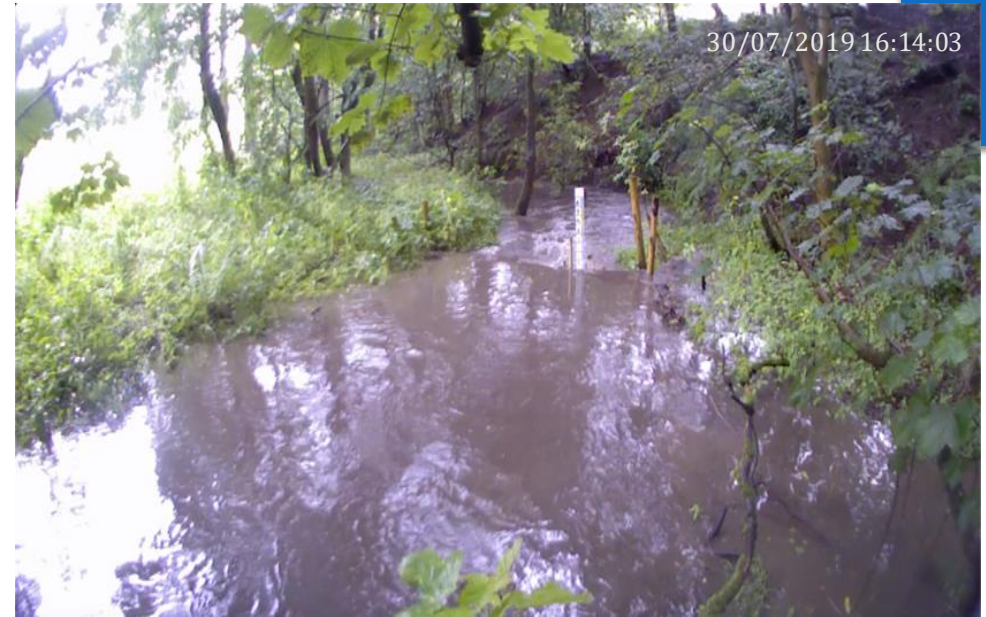
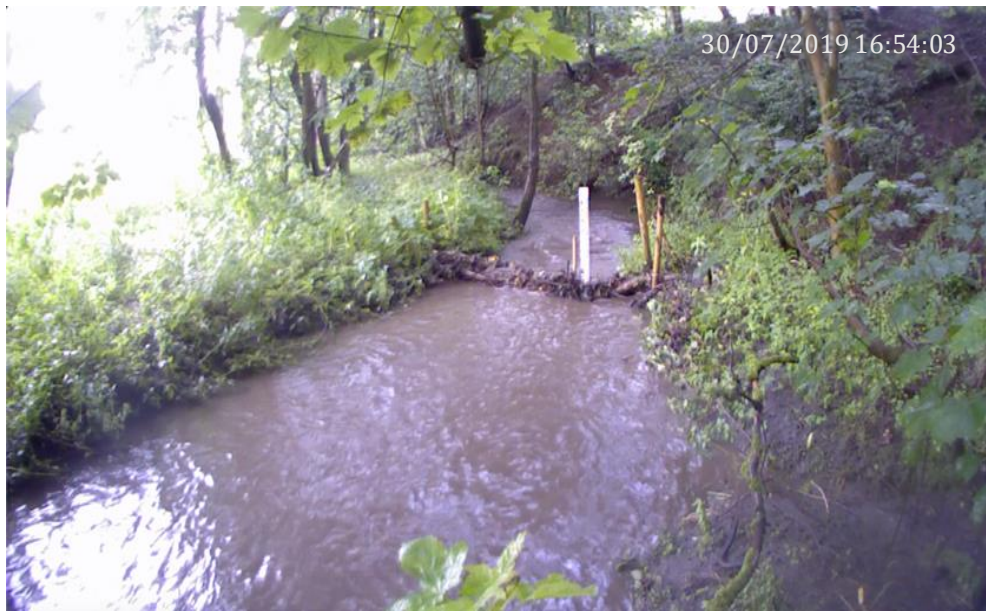
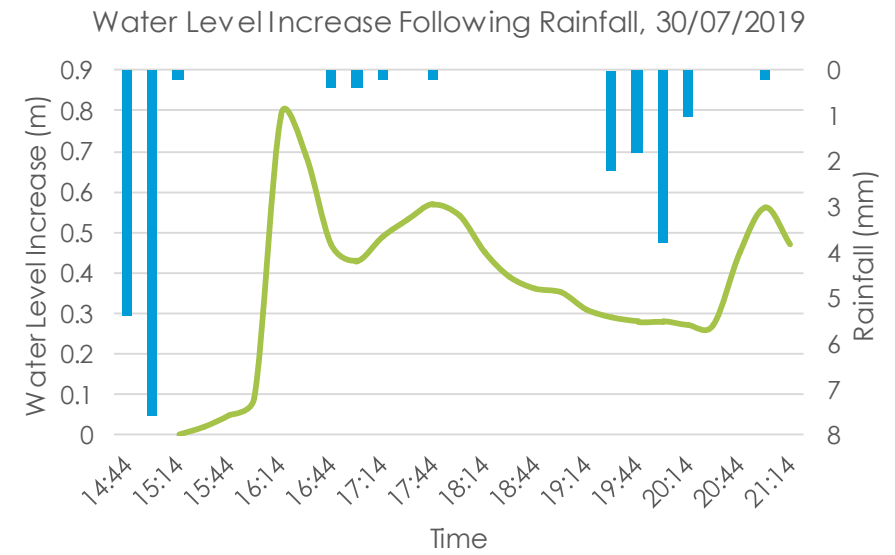
- ▶ The footage depicts occurrences of floodplain reconnection
- ▶ Paired with stage boards the river level rise could be measured
- ▶ We can determine how frequently the features are being activated
- ▶ We can monitor the impacts to the channel i.e. debris build up and the development of forced sediment bars
- ▶ Monitoring has allowed identification of potential improvements

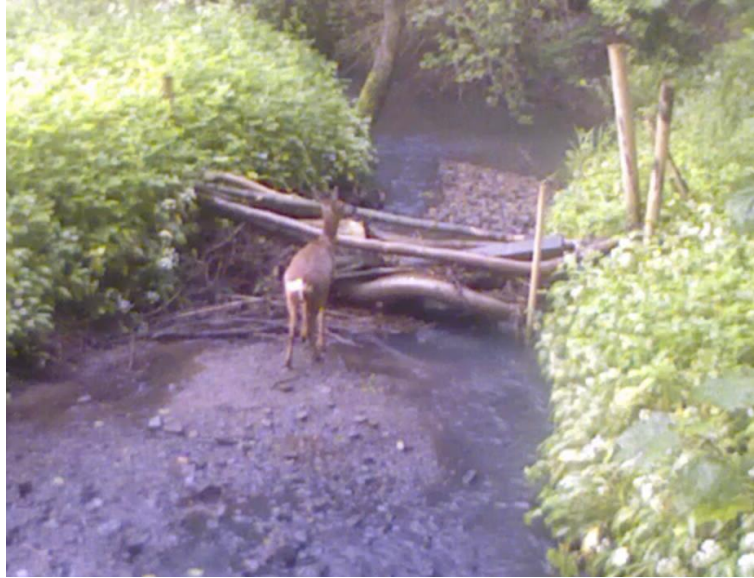
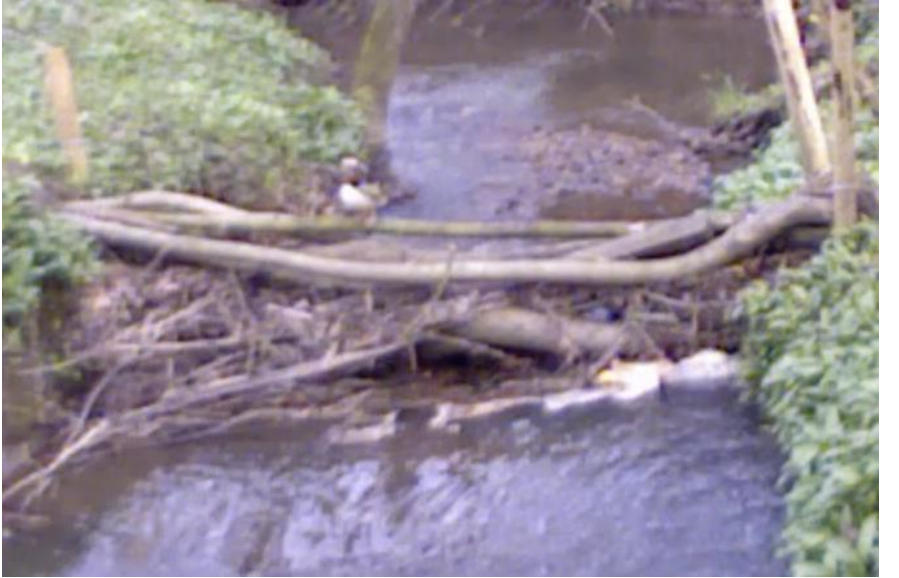
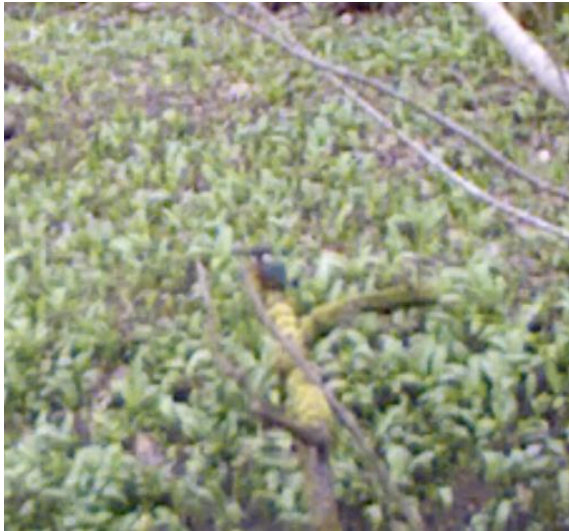
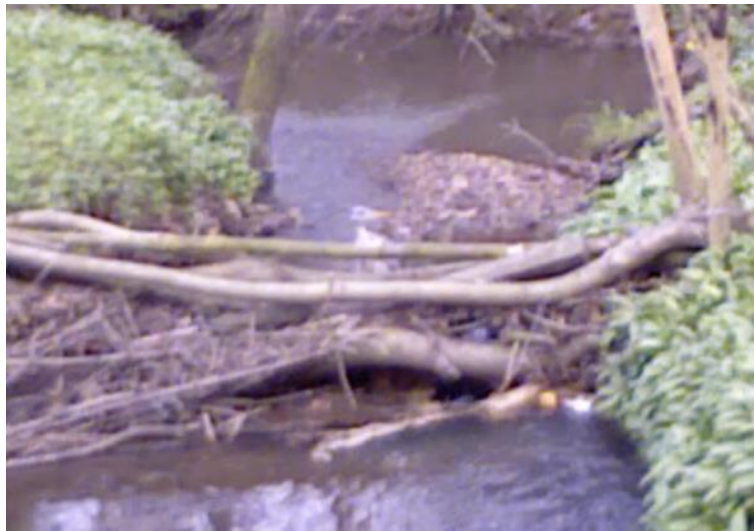
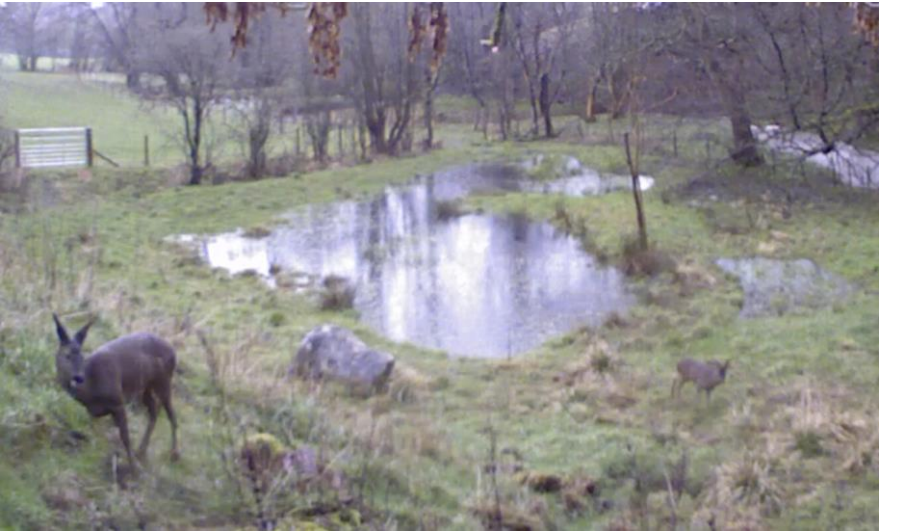
Multiple-Benefits - Habitats

- ▶ Additional benefits of NFM are sometimes difficult to determine
- ▶ The exclusion of cattle from the sites has allowed vegetation to develop and provided space for habitat development.
- ▶ Site 2 regularly attracted deer and has developed conditions suitable for pondlife
- ▶ Site 3 appears to be acting as a habitat corridor
- ▶ Visibility was reduced by the overgrowth of vegetation
